PROPERTY INSPECTION REPORT

8765 Sycamore

Inspection Prepared For: Commercial Client

Date of Inspection: 6/8/2021

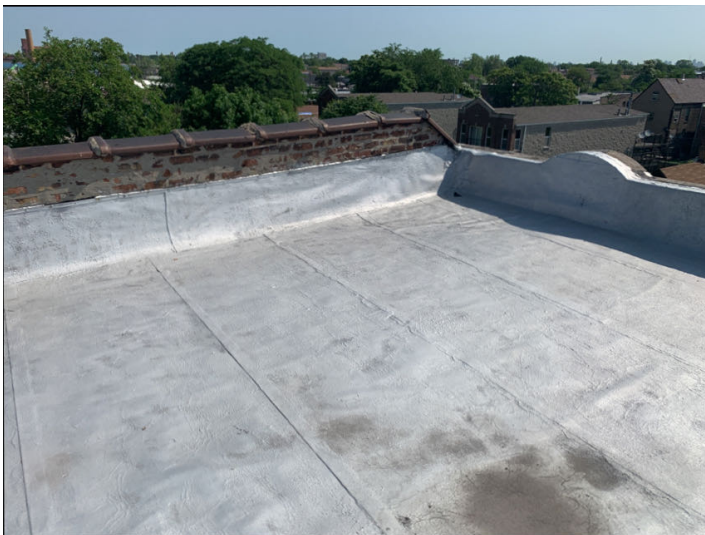
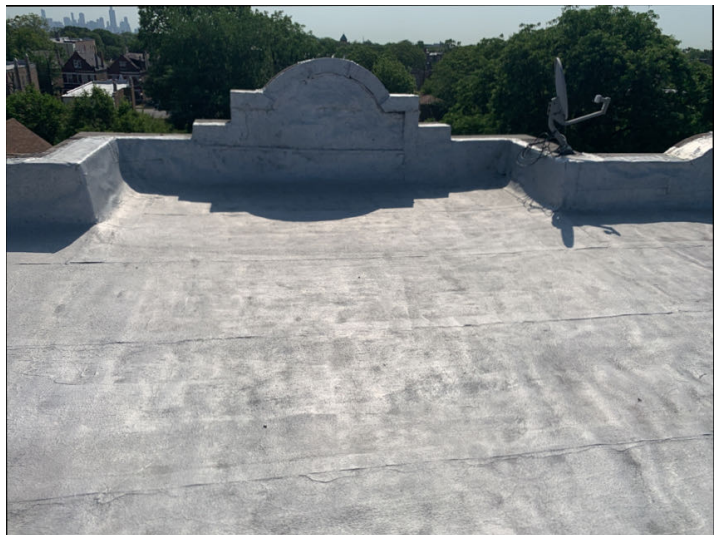
- Evidence of **ponding** was observed in one or more areas. Low spots in the roof allow water to collect and will eventually cause roof leaks (if not already leaking). **Further evaluation** by a qualified roofing **contractor** is recommended.

- Open seams in the roof material were noted in one or more areas. These seams are allowing water to get under the roof surface and immediate repair by a qualified **contractor** is recommended.

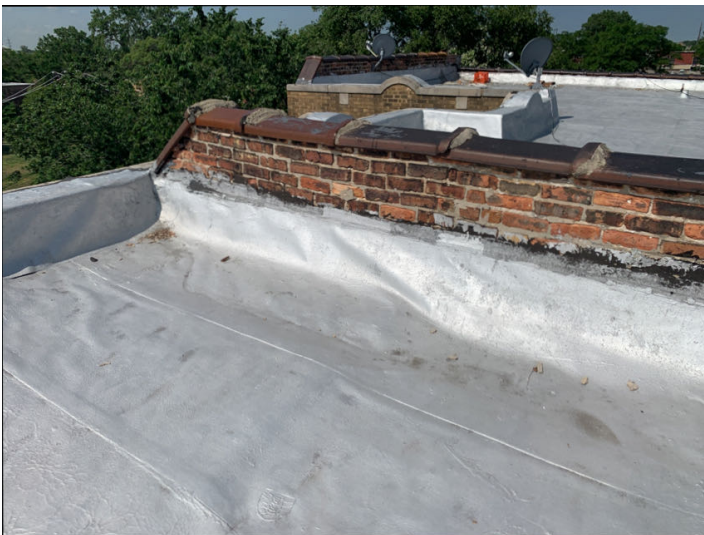
- The termination bar is the mechanical fastener which attaches the roof materials to the **parapet wall**. All gaps in this bar should be sealed and visually reviewed periodically.
- The potential for water entry is present at: parapet connection along the north side. There are openings present.
- Loose or failed termination bar noted along the east **parapet wall**.

poor termination bar

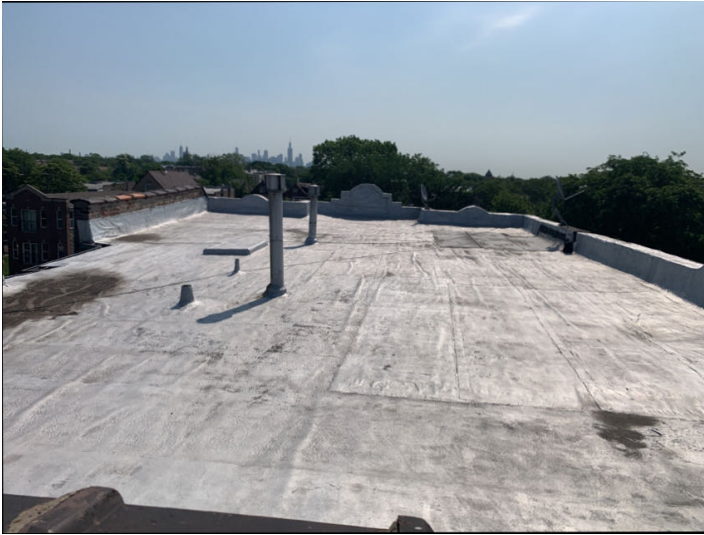
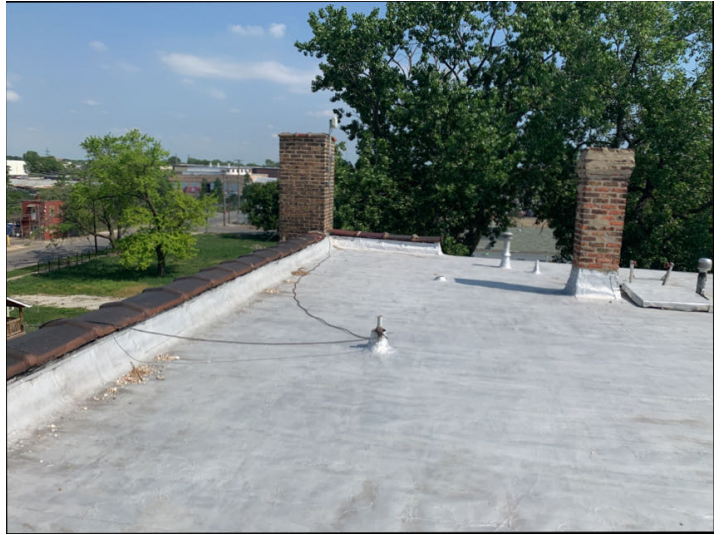
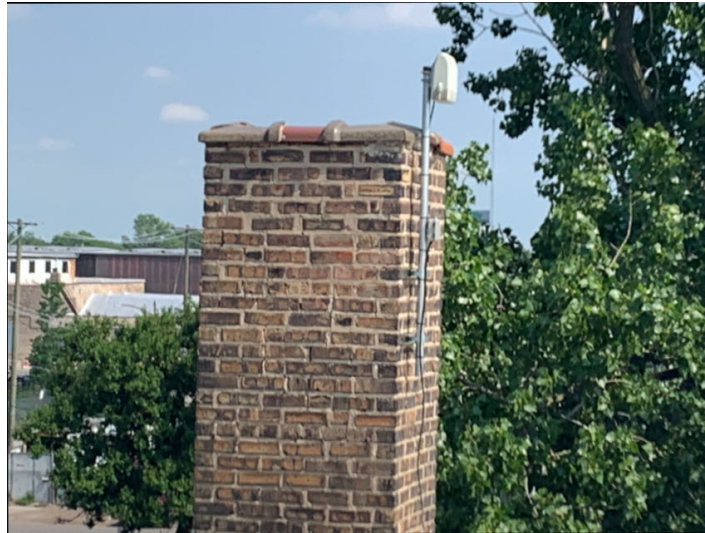
- There did not appear to be a flue liner within the chimney when observed from the top. While common in older buildings, this is a potentially hazardous condition. **Further evaluation** by a qualified **contractor** is recommended.

unlined

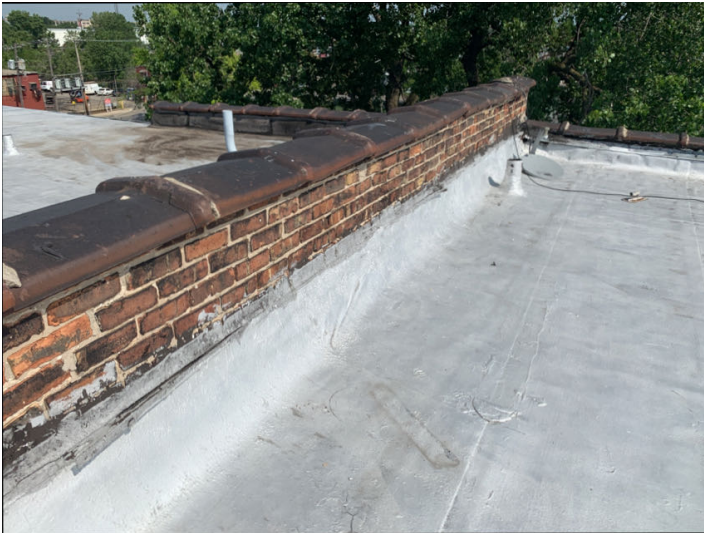
poor termination bar

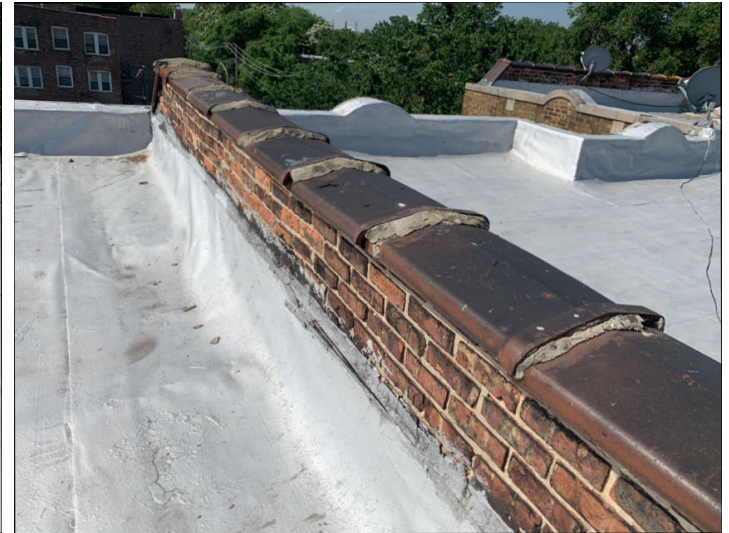
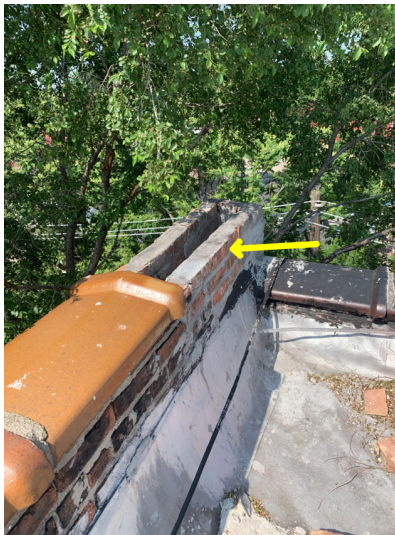
- There are openings in the seams of the coping. Each opening is a potential source of water entry or damage. Sealing is recommended.

missing coping

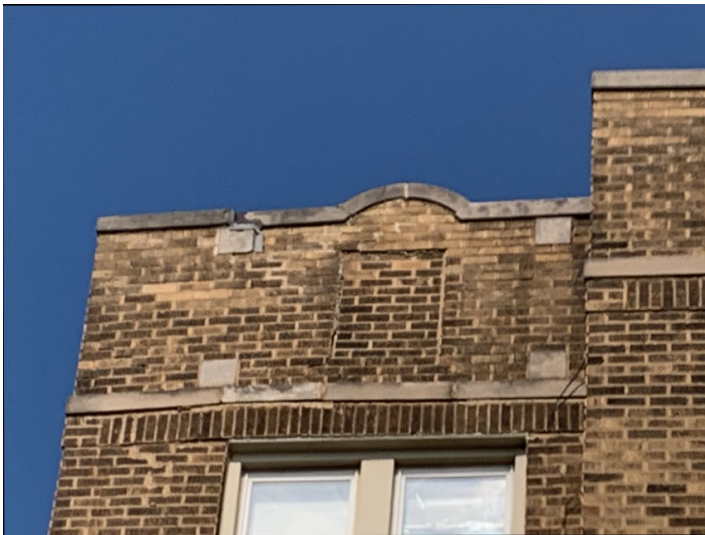
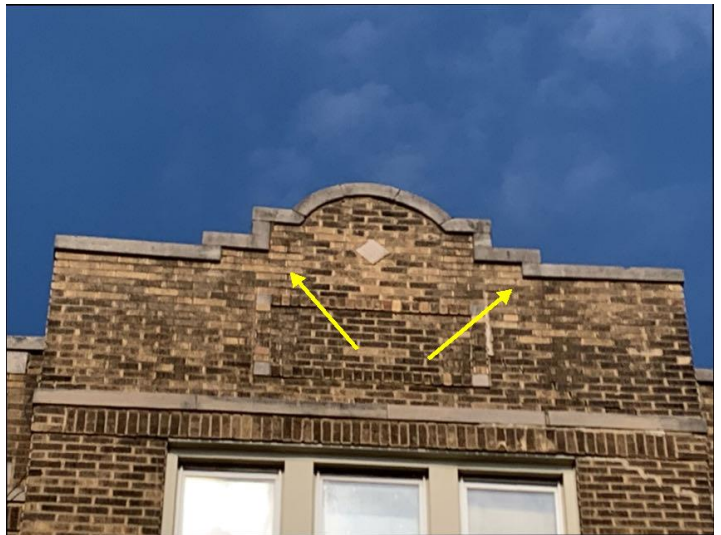
- Typical caulking maintenance is recommended at one or more areas in order to prevent moisture damage to the underlying wall surfaces.
- Missing, deteriorated and/or loose mortar was observed at one or more areas. This could allow moisture infiltration and potential for damage to the brick surfaces. Proper tuckpointing (replacement of the loose mortar joints) by a qualified **contractor** is recommended.

- The metal lintels installed above window and/or door bricked openings are rusted at one or more areas. Steel expands as it rusts, which could damage the surrounding brick. Recommend treating the metal with rust inhibiting finish to prevent further deterioration from occurring.

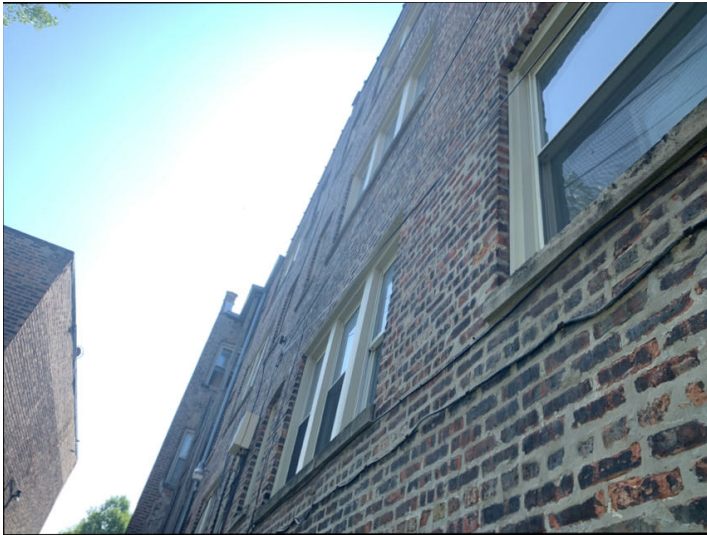
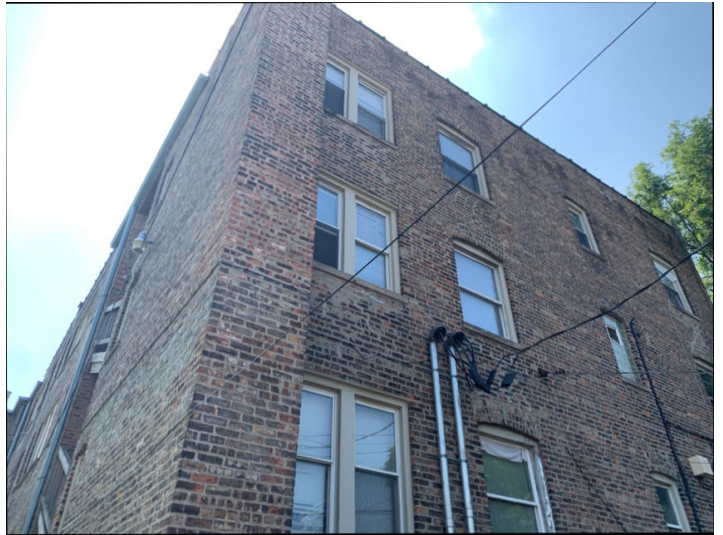
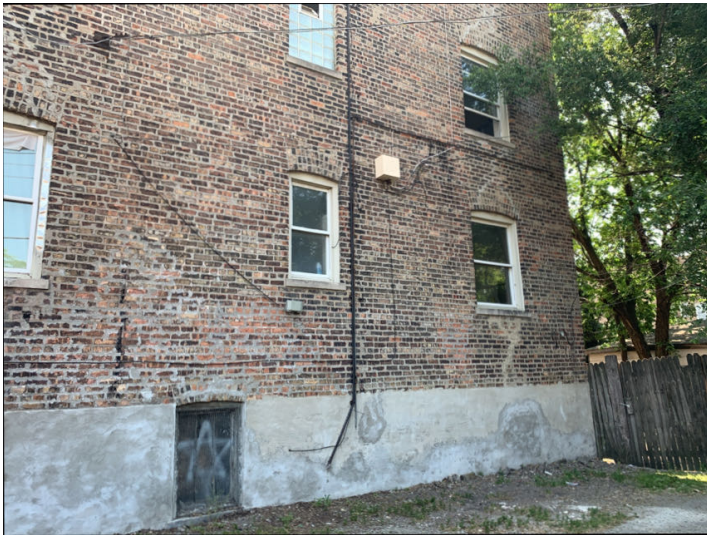
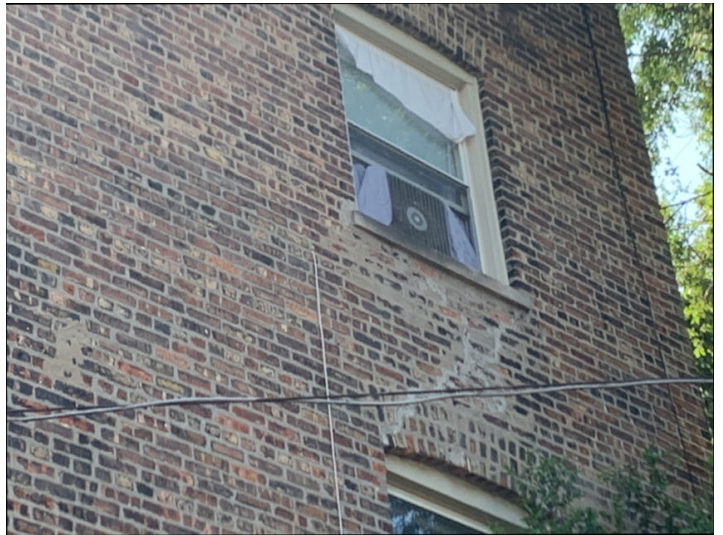
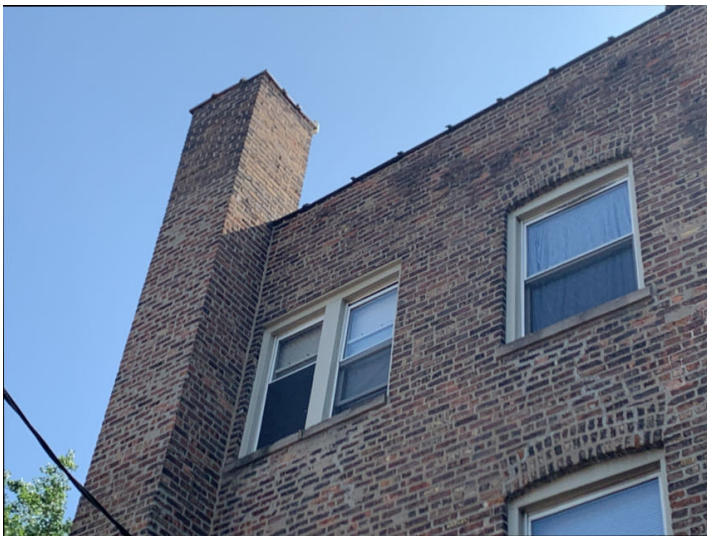
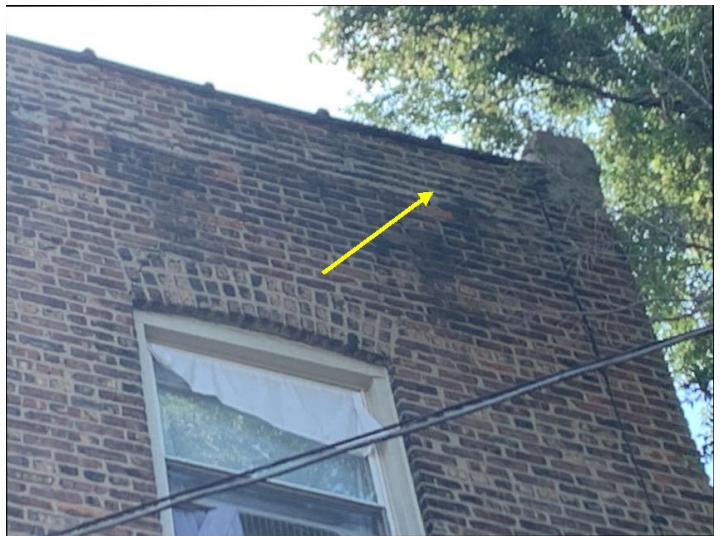
repairs

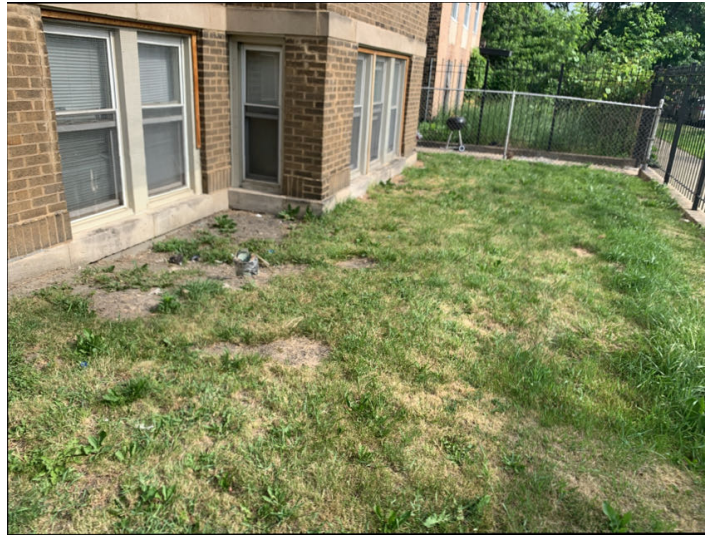
- Scheduled maintenance of landscaping appears to be lacking. We recommend a licensed landscape maintenance company be contracted with to properly maintain the grounds.

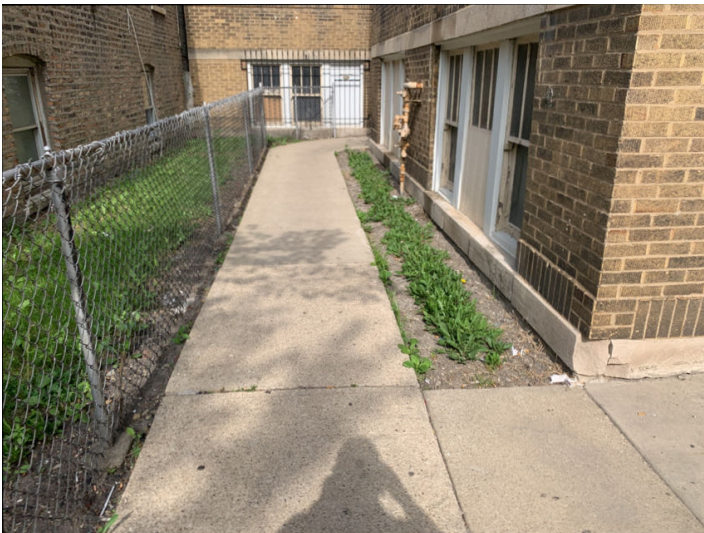
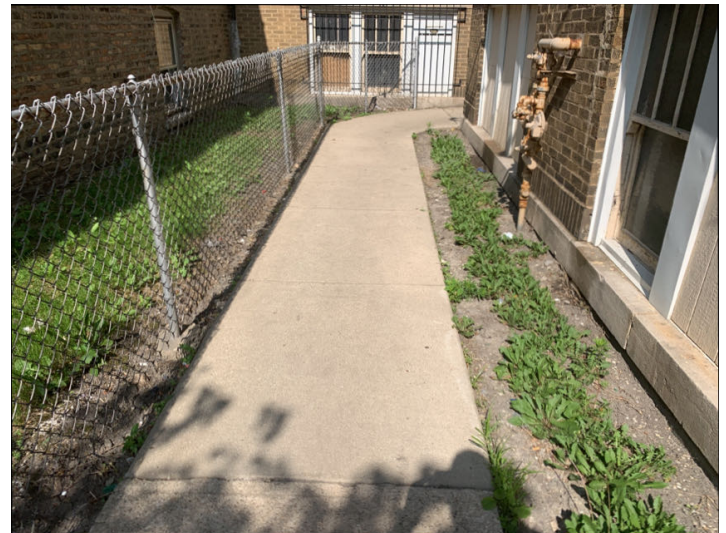
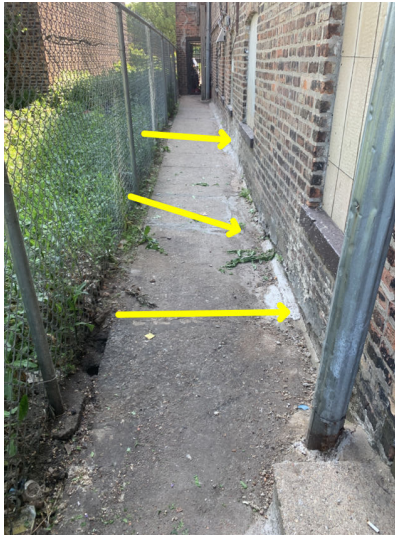
- Typical settling cracks were noted. All concrete, asphalt and **masonry** surfaces eventually crack, (it's just a matter of degree), and the cracks observed appear to be normal. The **life expectancy** of driveway and sidewalk paving is about 40 to 50 years.
- Sidewalk appears to be sloped toward the building at the north side of the building. This condition can cause excessive moisture near or under structure.

poor slope

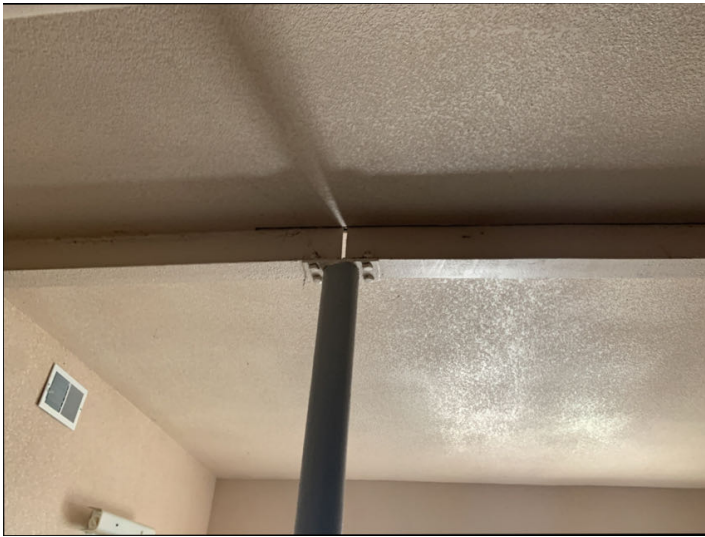
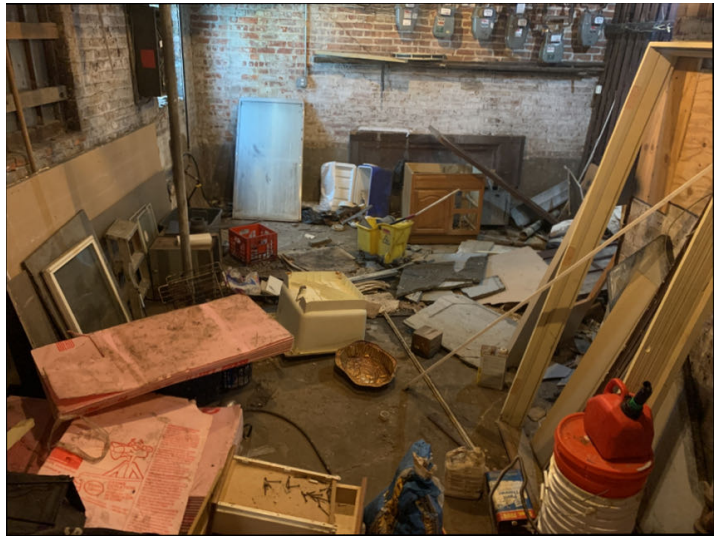
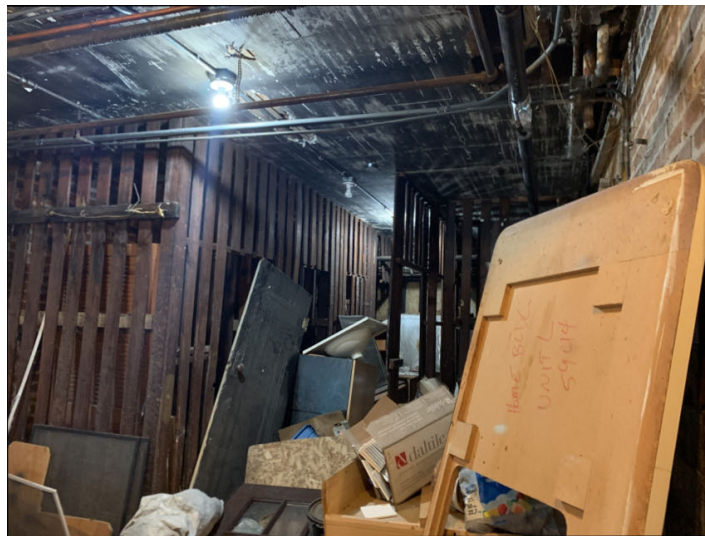
- Access to the foundation walls was limited by personal possessions or other items, and a thorough review could not be conducted. Defects may exist which were hidden by the stored items. Recommend a proper review of these areas after the items have been removed and before the closing.

- A dark material that could be mold was noted at one or more areas of the foundation wall. This is an indication of excess moisture, either from leaks or **condensation**/humidity. Proper removal of the dark material is recommended however, the actual presence of mold can only be determined by proper testing, which is not a part of this inspection.

poor access

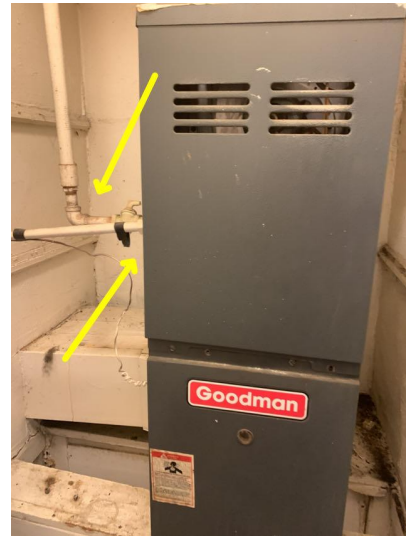
3W older Missing drip leg on gas

- The gas **system** for this structure appears to be in serviceable condition at all areas which were visible
- Drip legs are missing at appliances, devices, or certain distribution locations which require them. Flexible gas lines should also not be in areas where they can come into contact. The basement unit has flexible gas lines.

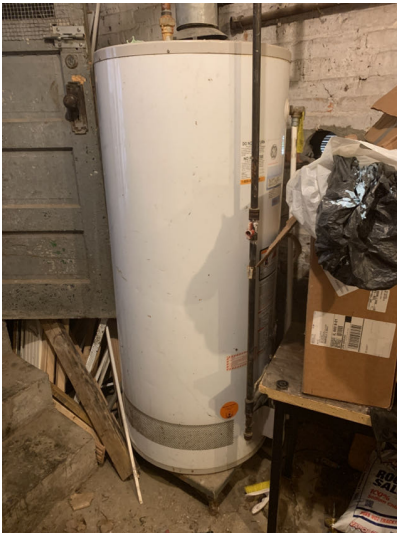
- View of the water heater(s).
- The flue draft has been partially crush or not fitting properly. This is cause the unit to not draft correctly.

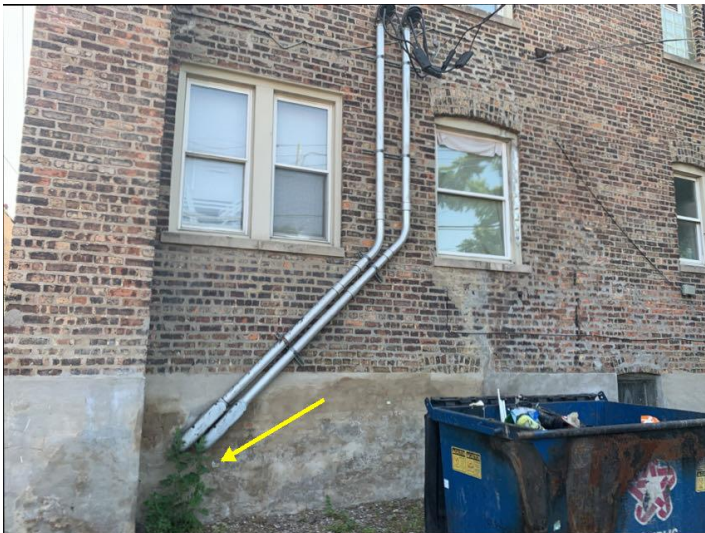
- View of the main Service Equipment.
- The overhead service is without an exterior driven rod ground.

missing ground

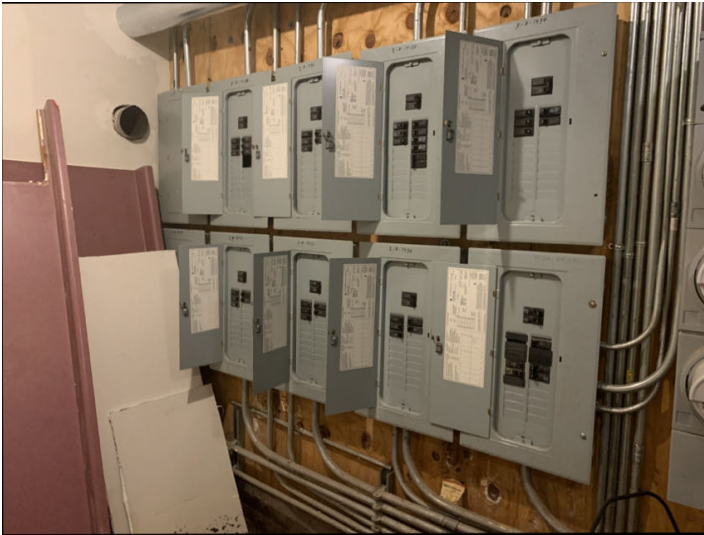
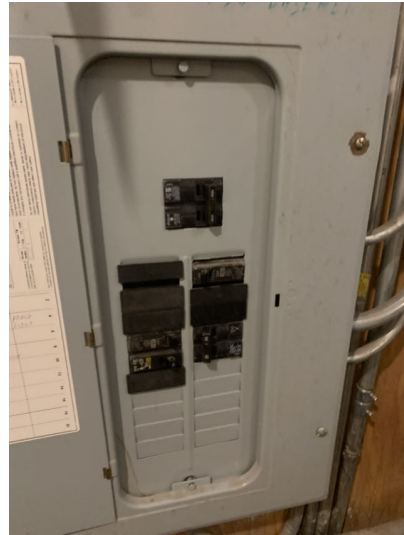
- Labeling of breakers is incomplete, inaccurate or not legible.
- There is some type of equipment or cabinetry installed within the dedicated space immediately in front of this panel. Typically, there is a dedicated space of 36" required in front of all electrical equipment.
- Unused openings in the panel are missing covers. These covers can be either plastic or metal and are called knock-outs, they are available at most hardware stores for less than a dollar. They simply clip into place without the use of any tools. However, they are important because without them one could stick their fingers into the panel and come into direct contact with high voltage.

open knockouts

Page 37 Item: 1	Panels and Switchboards	<ul style="list-style-type: none"> • Unused openings in the panel are missing covers. These covers can be either plastic or metal and are called knock-outs, they are available at most hardware stores for less than a dollar. They simply clip into place without the use of any tools. However, they are important because without them one could stick their fingers into the panel and come into direct contact with high voltage.
-----------------	-------------------------	--

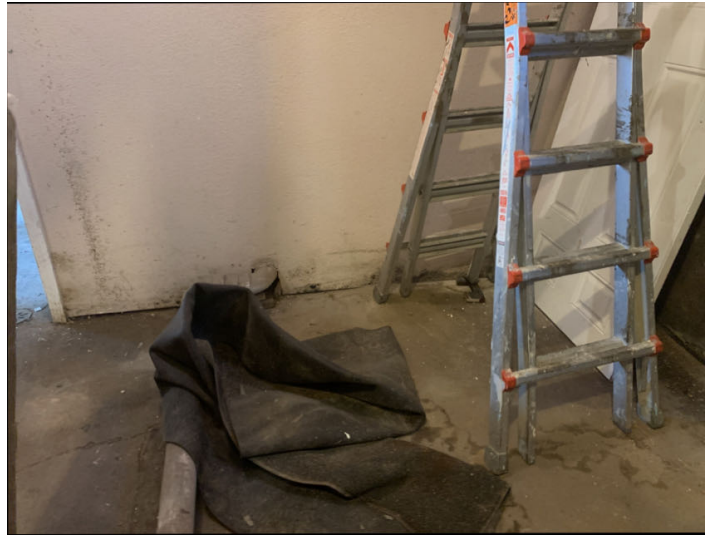
Water damage was observed on areas of the drywall(s). Recommend checking with the current owner as to when the water damage occurred. It is also suggested to repair or replace the damaged materials.

mold stains in basement

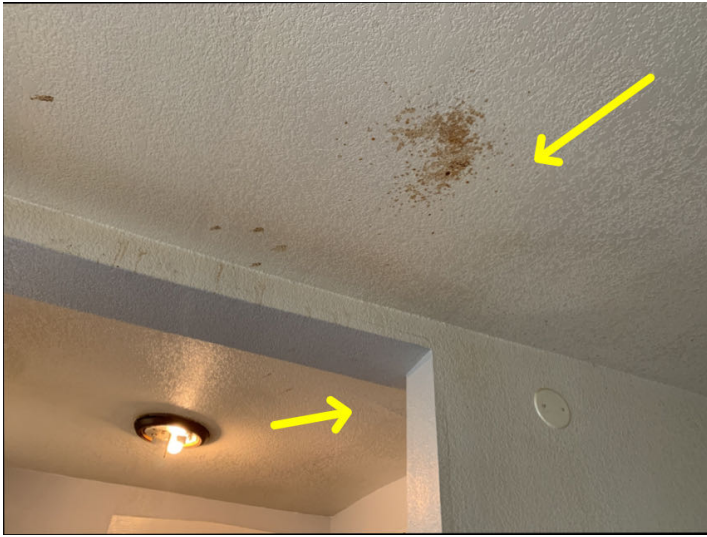
1W leaking and stained

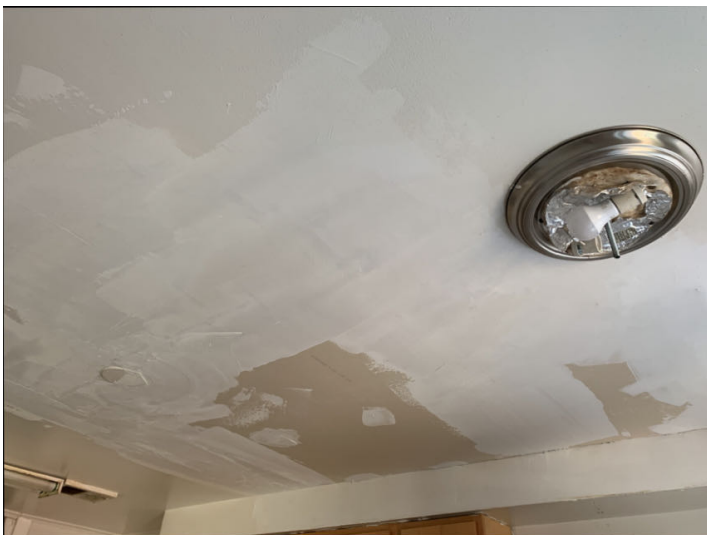
2D repaired ceiling

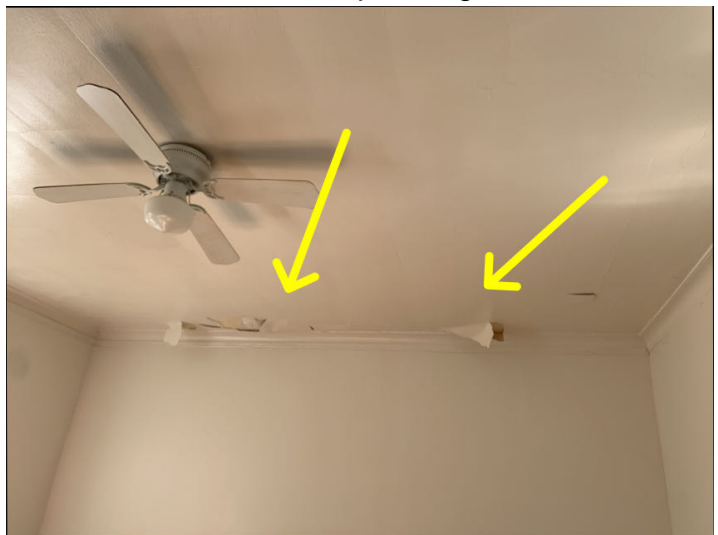
2D peeling materials

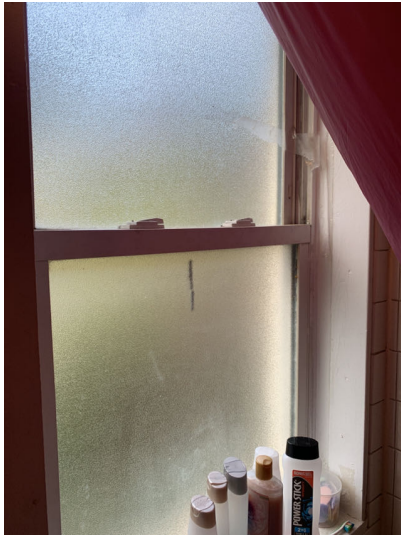
The vacuum seal has failed ("lost seal") in the insulated glass in some of the windows. While the "fogging" of the glass is largely cosmetic, there is an accompanying loss of **insulation** value. This condition can only be corrected by replacement of the entire, factory assembled glazing unit by a qualified window **contractor**.

1E Failed seal

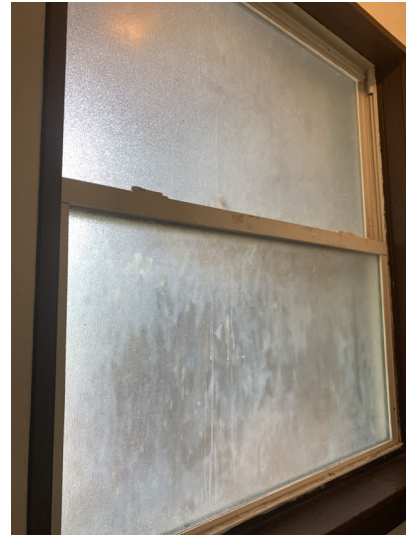
failed seal hall 3W

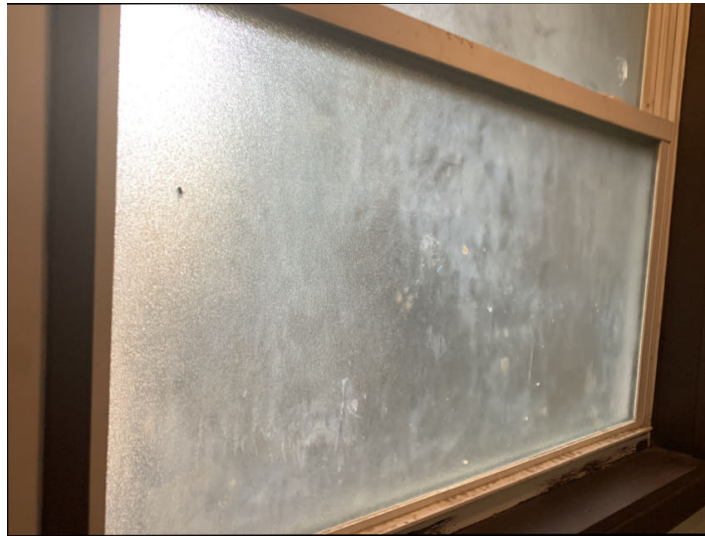
failed seal 3E

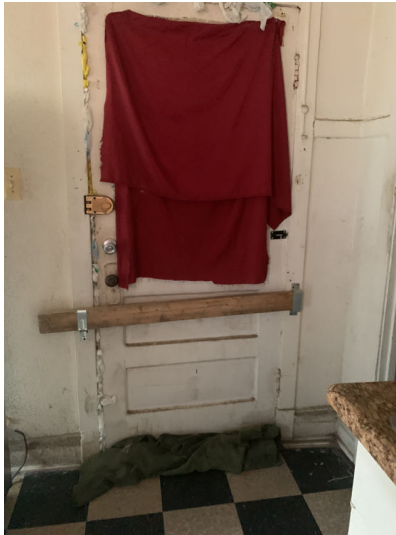
2W blocked door

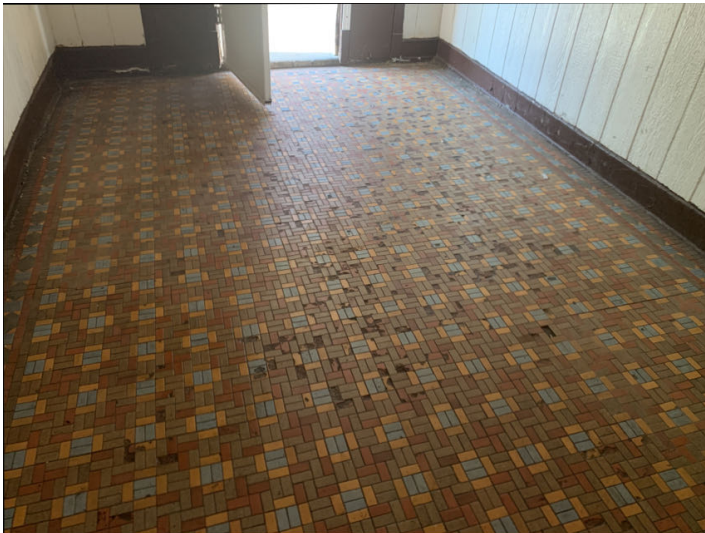
Main entry 1430

The flooring was noted to be damaged in some areas. While minor damage may be cosmetic, repair or replacement of areas of significant damage is recommended.

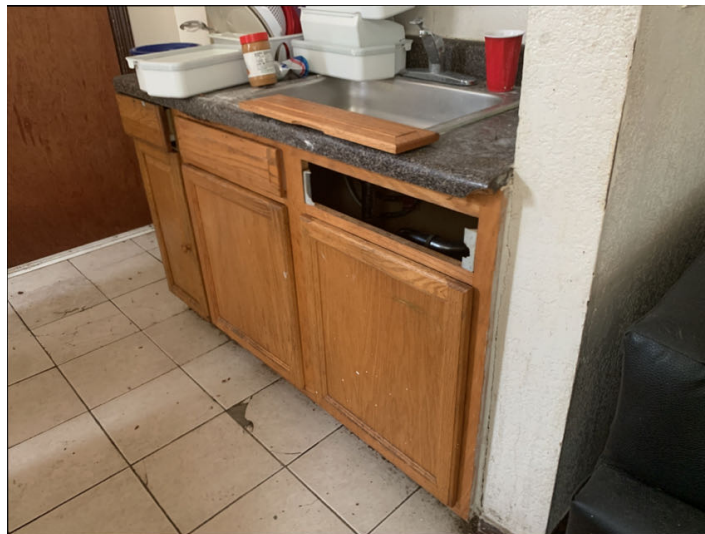
3W

The cabinets had doors and/or drawers that were missing at the time of the inspection. Replacement of the missing components or of the cabinets is recommended.

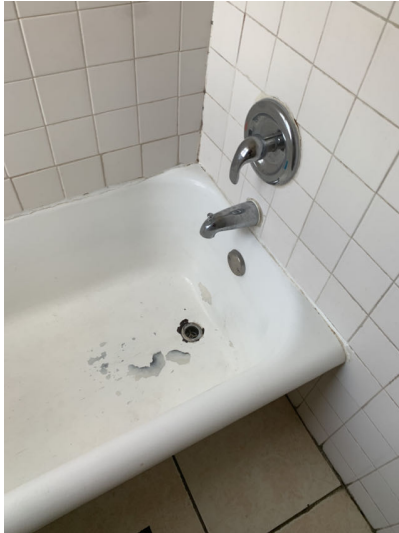
3E surface damage

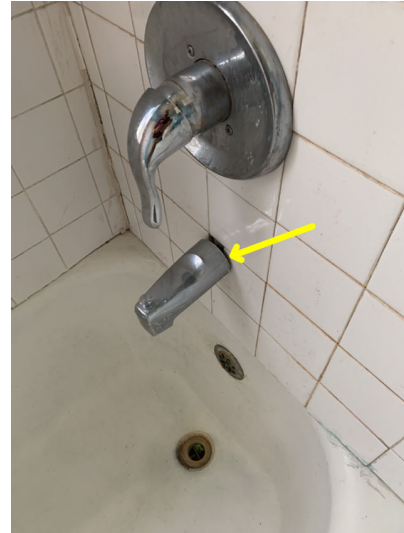
There is a large gap between the tub spout and the wall surround. This gap is an excellent area for water to enter the wall and cause damage. Sealing this gap or decreasing the distance is strongly encouraged.

1E2 gaps

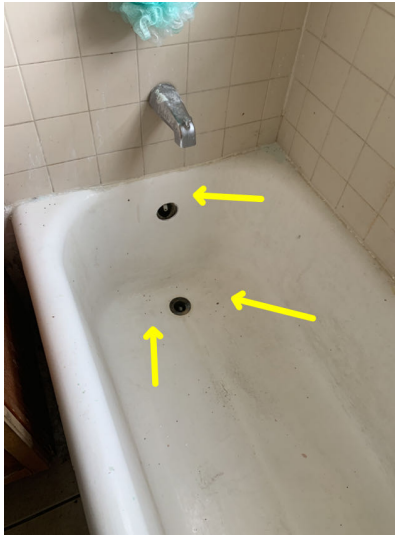
The overflow cap is installed upside down or is loose. This may lead to leaks behind the drain, recommend the installation of proper cap by a qualified contractor.

3W Missing overflow and damage

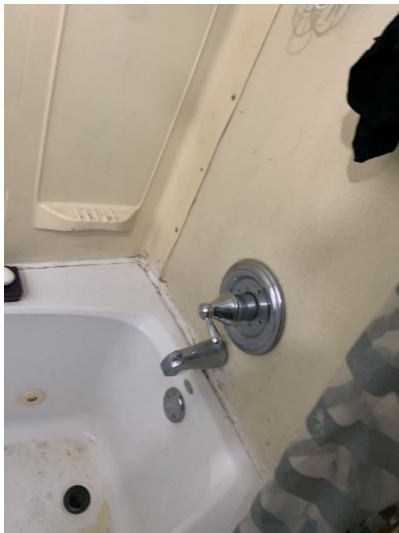
The tub spout was loose. Proper correction is recommended to prevent possible leaks within the wall.

Garden - loose

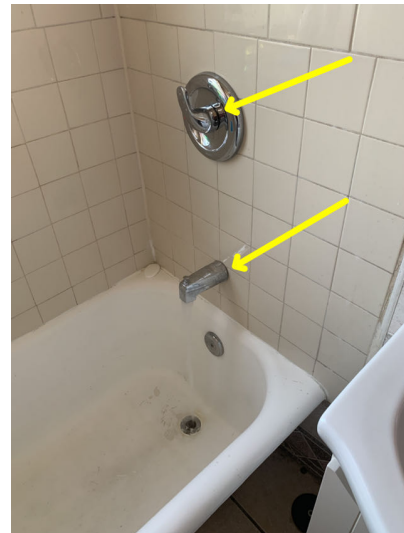
The tub spout was loose. Proper correction is recommended to prevent possible leaks within the wall.

3E2 loose with gaps

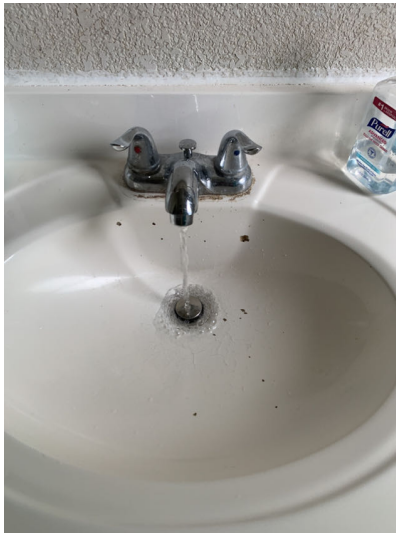
The sink finish was noted to be chipped and/or cracked in some areas. Proper touch-up or refinishing is recommended to prevent further deterioration.

There is a large crack in the sink basin. While this crack may not be leaking, it is considered a defect in the finish and is a potential area where bacteria could grow.

2W loose faucet and damaged basin

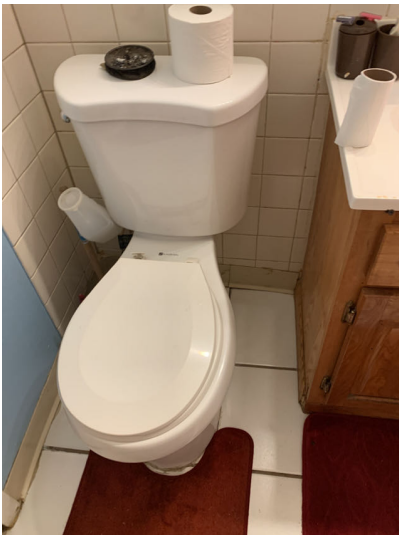
The toilet fixture appeared to be loose at the floor. This condition can cause the toilet to leak at the base, potentially causing damaged and/or rotted flooring. Proper correction by a qualified **contractor** is recommended.

Loose 1E

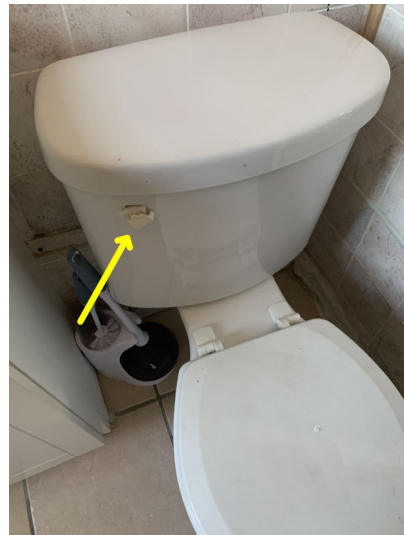
The flush handle was noted to be loose, stripped or broken. Proper correction is recommended.

3E2 flush handle
